NUREG/CR 1127  
NRL Memorandum Report 4121

**Fractographic and Microstructural Analysis of Stress  
Corrosion Cracking of A533 Grade B Class 1 Plate and  
A508 Class 2 Forging in Pressurized Reactor-Grade  
Water at 93°C**

January 25, 1980

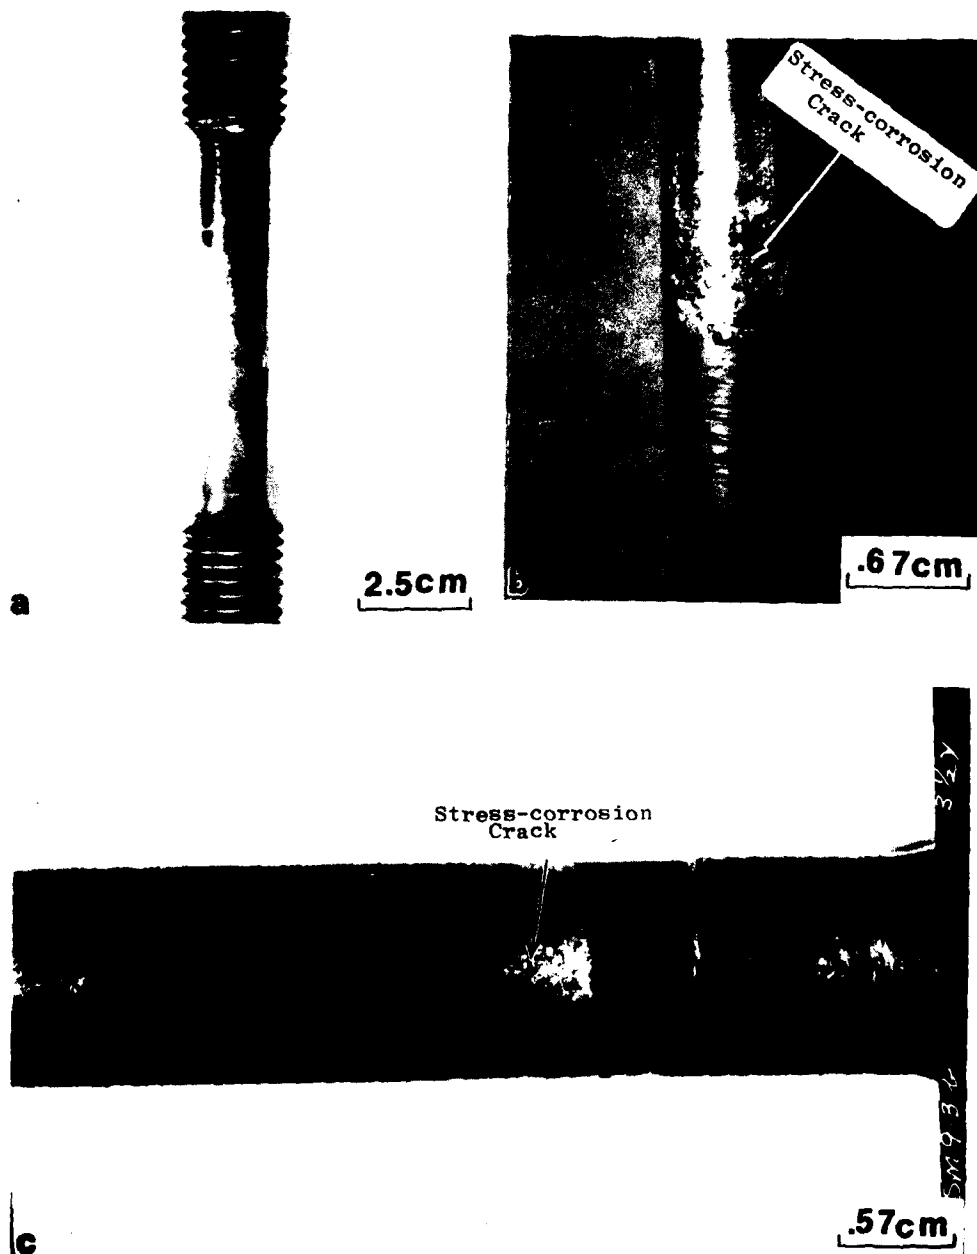
cracks were clearly visible with the unaided eye, and they ranged in circumferential length from 1.5 mm (0.060 in.) to 9 mm (0.360 in.); the depth of the largest crack was about 3 mm (0.12 in.). No cracks were seen in the A533-B-1 specimen which had been tested under identical experimental conditions. The photographs in Fig. 1 show the appearance of the A508 tensile specimen. These photographs show the entire specimen (Fig. 1a), the largest of the seven cracks (Fig. 1b), and a smaller crack (Fig. 1c). As can be seen from the photographs, the cracks are oriented perpendicular to the direction of the applied stress. Some other smaller cracks found also on the gage section of the A508-2 specimen are shown by the SEM micrographs in Fig. 2.

**Fig. 1.** Optical photographs of A508-2 tensile specimens used in the SCC testing. Photograph (a) shows the entire specimen, photographs (b) and (c) show some of the larger cracks that developed on the gage section following exposure to reactor-grade water at  $93^{\circ}\text{C}$  for 2000 hr.

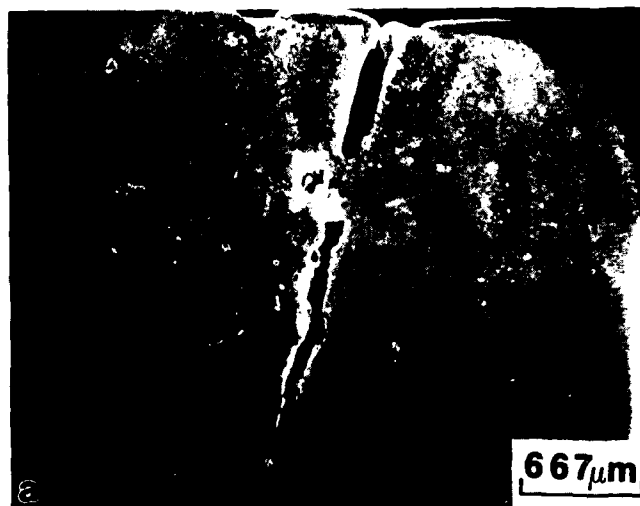
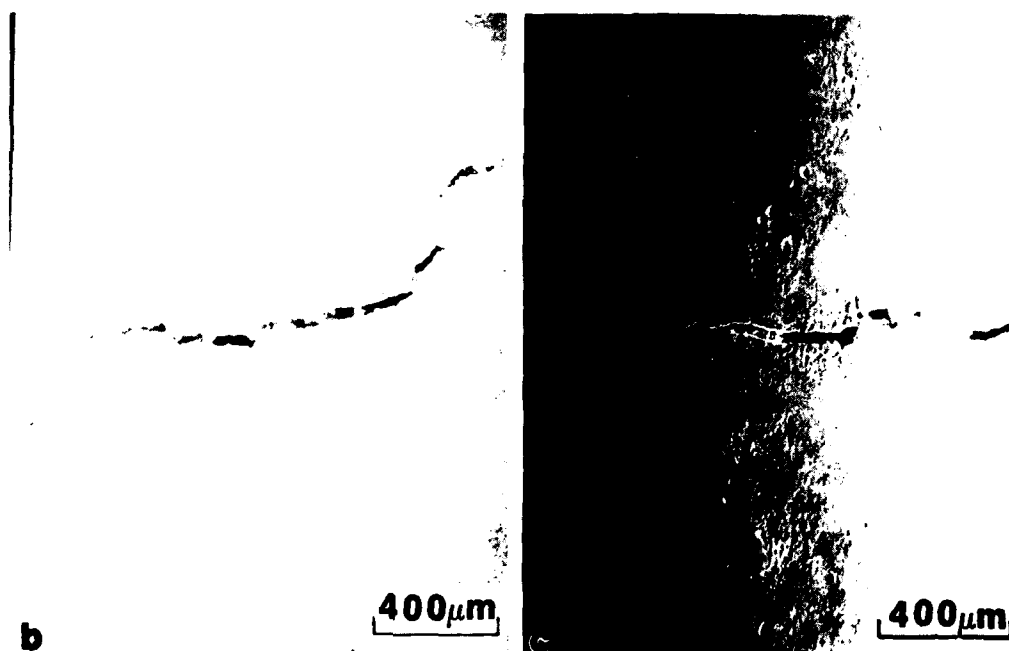
**Fig. 2.** SEM micrographs of gage and the transverse gage sections of A508-2 tensile specimen. Prior to SEM examination, the transverse section was metallographically polished and etched in 1 percent nital solution, the gage section was ultrasonically cleaned in alcohol and acetone. Fig. 2a shows the depth of the largest crack; Figs. 2b and c show two smaller cracks that developed during the SCC tests.

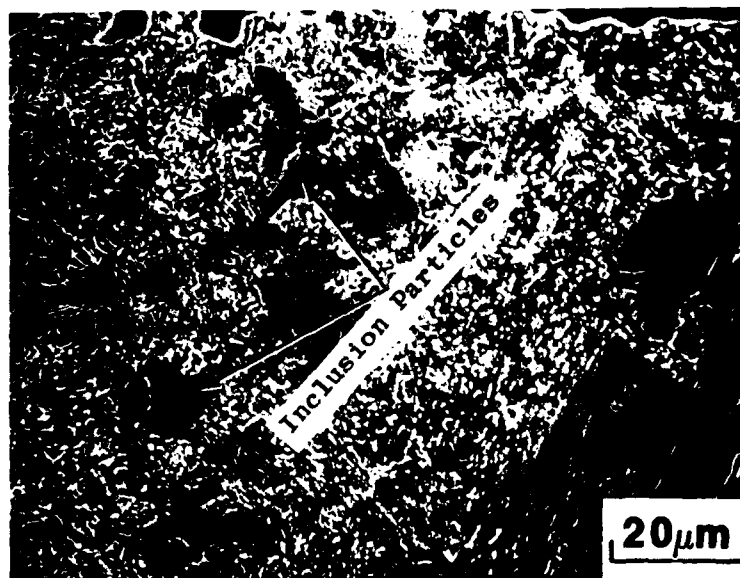
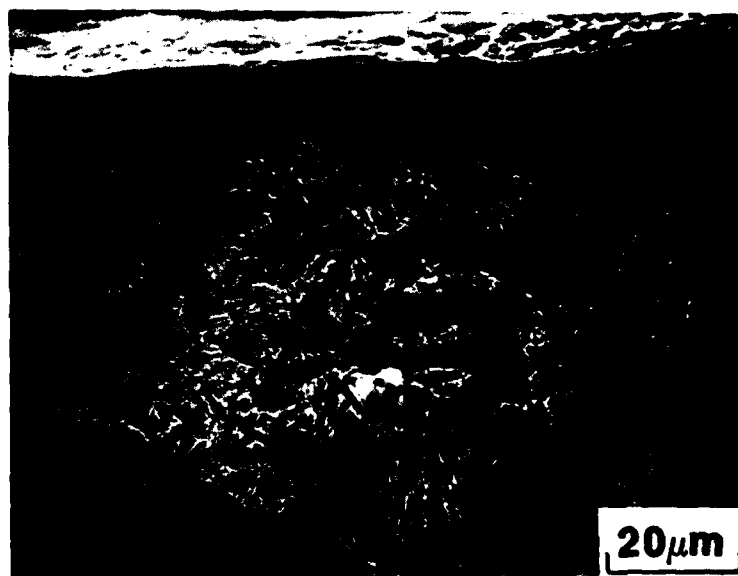
The SEM micrographs in Fig. 3 show typical features of the microstructure of A533-B-1 plate and A508-2 forging materials; these micrographs were taken from the polished and etched sections of the two specimens. The microstructure of the A508-2 forging (Fig. 3a) shows several inclusions and coarse carbides. On the other hand, the microstructure of the A533-B-1 plate (Fig. 3b) shows smaller carbides and fewer inclusion particles. An additional microstructural evaluation of the two steels showed that the microstructure of A508-2 forging was ferritic-pearlitic with small amounts of bainite, whereas that of A533-B-1 plate was completely bainitic. Figure 4 is a montage of SEM micrographs of a polished and etched section of A508-2 specimen showing one of the many microcracks that were present in this specimen. The microcrack started from the outside surface and propagated along the inclusion-matrix material interface. As can be seen in the micrographs, decohesion also occurred along the carbide-matrix interface. The SEM micrographs presented in Fig. 5 are higher magnification micrographs of the crack tip areas of the cracks shown in Fig. 1b and 2a and the microcrack in Fig. 4. Small voids are observed in the vicinity of the crack tip in both cases. These voids are similar to ones observed in a parallel study of the fatigue crack growth resistance of A508-2 forging steel in reactor-grade water at temperatures up to 288°C (550°F) [8]. In that study it was suggested that the small voids are the sites to which hydrogen can most easily diffuse and be trapped.

**Fig. 3.** SEM micrographs of A508-2 forging and of A533-B-1 plate specimens. The micrographs were taken from the transverse sections of the specimens. The microstructure of A508-2 (Fig. 3a) is characterized by large amounts of carbide and inclusion particles; the microstructure of A533-B-1 (Fig. 3b) has fewer carbide particles and it is almost free of inclusions.

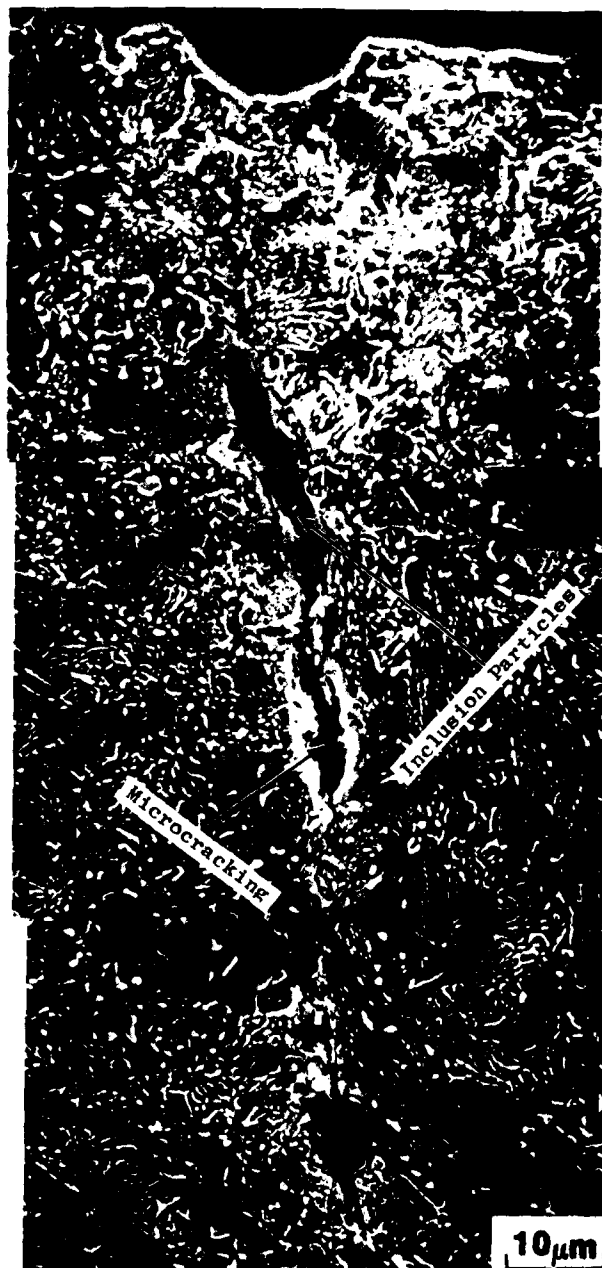
**Fig. 4.** Montage of SEM micrographs of a transverse section of A508-2 specimen. The montage shows one of many microcracks found on the transverse sections after the SCC test. The microcrack originated at the outside surface and propagated along the inclusion-matrix and carbide-matrix interfaces.

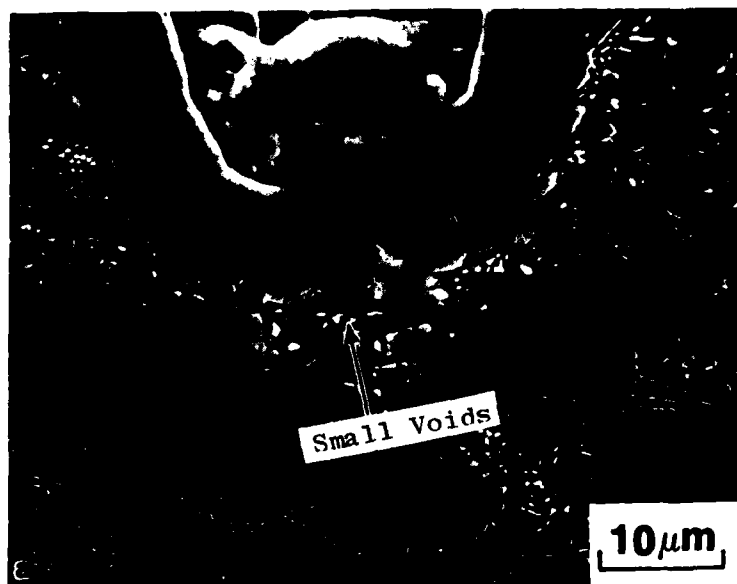
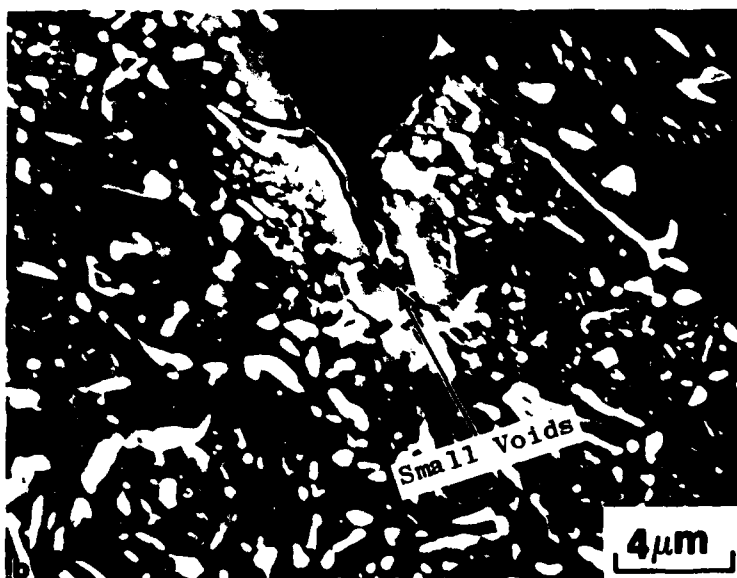
Fig. 5. SEM micrographs of transverse sections of A508-2 tensile specimen. Micrograph (a) is an enlarged view of the crack tip shown in Figs. 1b and 2a; micrograph (b) is an enlarged view of the tip of the microcrack shown in Fig. 4. The micrographs show the presence of small voids near the tips of both cracks.

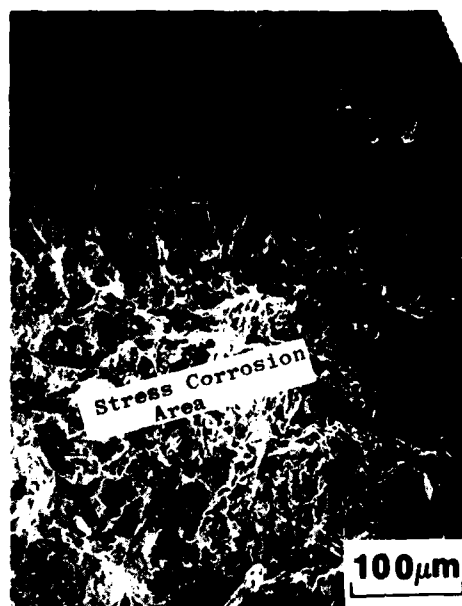
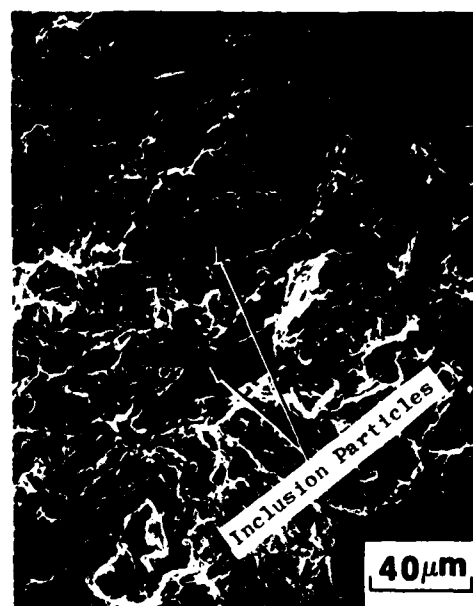
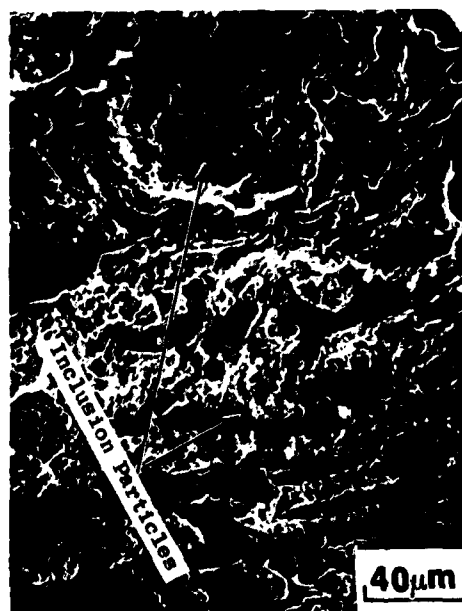
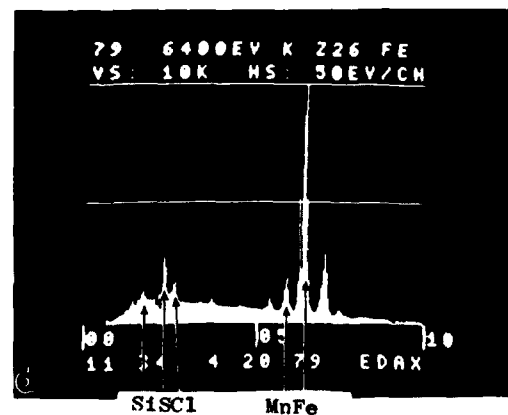
The significant fractographic features observed on the stress corrosion area in one of the several cracks found in the A508-2 specimen are illustrated in the SEM micrograph presented in Fig. 6. Figure 6a is a lower magnification micrograph that gives a general view of the stress corrosion area. The failure mode appears to be cleavage-like and inclusion particles are clearly visible on the fracture surface. The inclusions are quite evident in the adjacent higher magnification micrographs (Fig. 6b and c). The inclusion particles have an elongated shape and they are quite numerous. Panel (d) of the same figure is the energy dispersive x-ray spectrum of a small region in the stress corrosion area near an inclusion particle. The spectrum, besides the expected peaks of iron and chromium, reveal the presence of manganese, silicon and sulfur peaks and a small chlorine peak. The spectrum indicates that the inclusion particles are manganese-sulfide and silicate inclusions. The x-ray image scans presented in Fig. 7 refer to manganese and sulfur; similar image scans were obtained for the silicate inclusions.

Fig. 6. SEM micrographs (a, b, and c), and energy dispersion x-ray spectrum (d) taken from the stress corrosion crack of a A508-2 tensile specimen. This stress corrosion crack became accessible for SEM examination when one half of the specimen was broken at liquid nitrogen temperature along one of the several cracks that had developed on the gage sections. Micrographs a through c show cleavage-like fracture propagation along inclusion bands. The x-ray spectrum shows that the bands are silicate and manganese-sulfide inclusions.

A hydrogen-assisted cracking model has been developed to explain the above results. When the test specimen is exposed to a pressurized reactor-grade water at 93°C, an oxide layer is formed on the surface consisting mainly of hematite. Hematite is not protective, thus allowing further corrosion reactions to occur. Due to the presence of manganese-sulfide and silicate inclusions, the prevailing electrochemical conditions initiate a localized corrosion attack on the metal matrix around the inclusions [9,10] and a decrease of pH occurs [11,12]. Also the solubility of MnS even in pure water allows the formation of a sufficient concentration of HS<sup>-</sup> ions, which accelerates the corrosion reaction and hydrogen evolution [11,13]. Further enhancement of the corrosion attack may be caused by the migration of the chlorine ions into the crevice [9]. The energy dispersive x-ray spectrum shown in Fig. 6d provides support for this hypothesis.

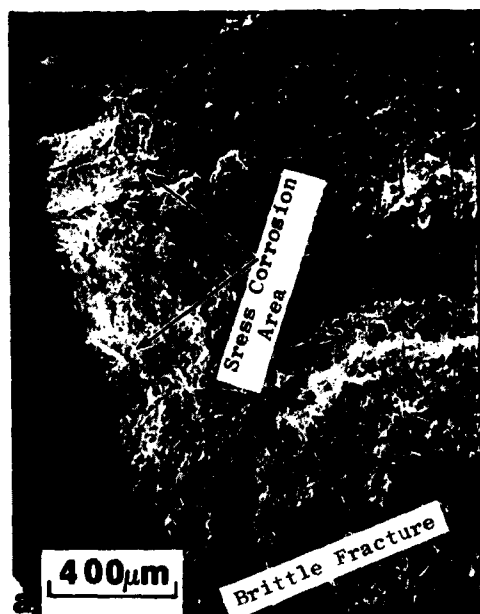
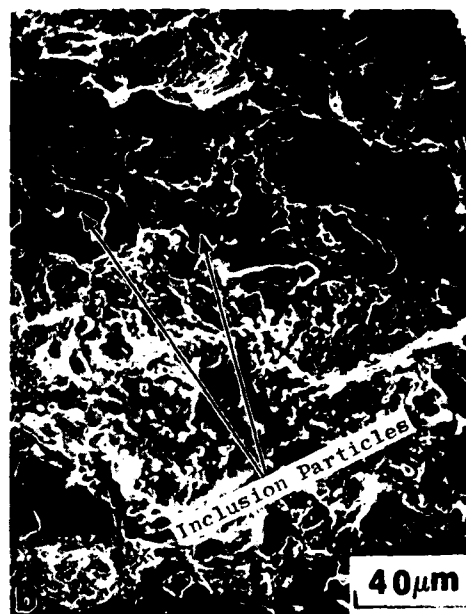
Fig. 7. Stress corrosion area (micrographs a and b) and corresponding energy dispersive x-ray image scans of A508-2 specimen. The stress corrosion area is the same one shown in the previous figure. The x-ray image scans refer to manganese and sulfur; similar image scans were obtained for the silicates.
